St. MARY'S CHURCH, MALTON (formerly Malton Priory)

North Door, west face

Mortars and condition

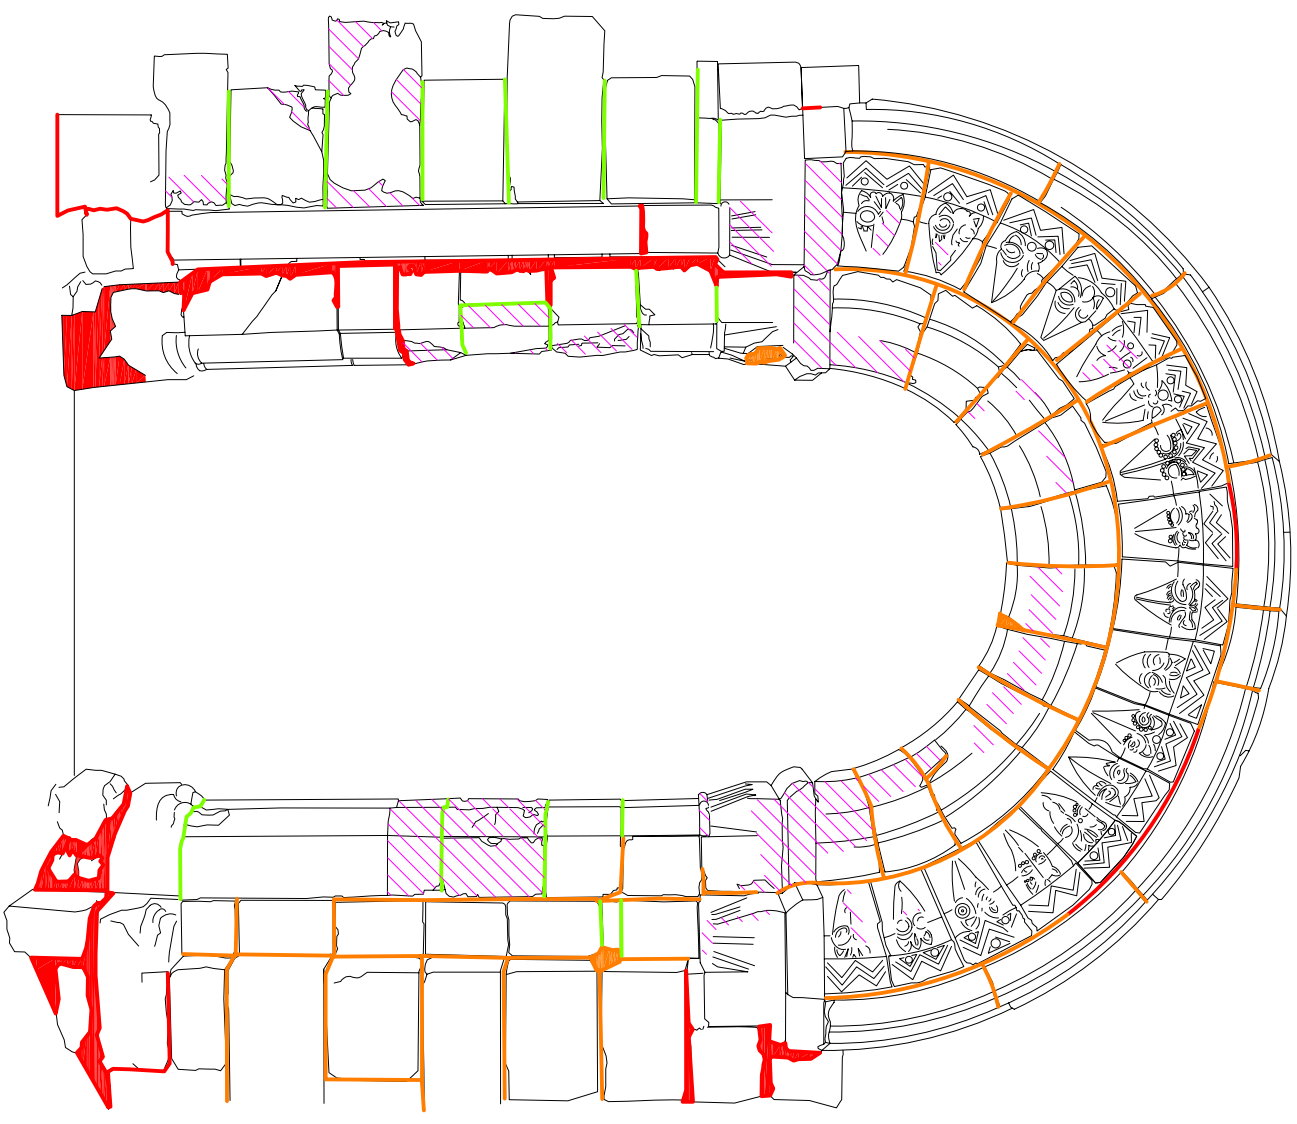
Salt-related decay
