Brief report into damp, interior of former Dodsworth's building, 9, Market Place, Malton

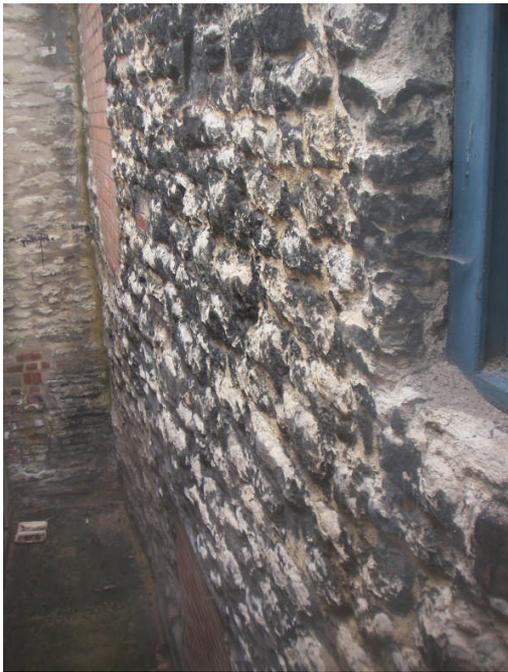
*Wall of 9, Market Place*

*outside wall of 8, Market Place, within light-well*

The light-well considered to be promoting damp within the building is itself a remnant from the medieval burgage plot – having originally been an alleyway/snicket/ginnel alongside the building. It has been largely absorbed into the buildings on the site, leaving but a 'light-well' to speak of its former function.

The masonry walls to either side of the light-well, therefore, are likely to be very old. They are built of the coursed malton oolite limestone, typical of later medieval buildings in the town, bound with mud mortar. Mud mortars were used in Malton until the C17 at least. Whilst the walls were probably pointed with lime mortar, this has often eroded away, leaving the earth mortar exposed, which is the case with the walls of the light-well. Sheltered from wind and driving rain, the walls within this area have gathered soot from chimney and vehicle exhaust pollution and are generally quite blackened with sulphate crusts. These crusts promote steady decay of the stonework. The ground within the light-well is concreted. Gutters are likely to leak or overflow and are probably blocked. This means that excessive water will find its way to the ground and will then seep from the impervious concrete into the soft and porous fabric of the walls. Further decay of the stonework and loss of lime mortar will enhance the potential for moisture to be absorbed into the fabric of these walls.

- A) Unblock and service all rainwater goods
- B) Defrass loose and decayed stonework, cleaning down the walls
- C) Repointing any empty or defective joints with a soft (putty or quick-lime) mortar, but leaving any full joints, though the mortar may be mud;
- D) Limewash the walls with 5 coats of white limewash, made with quicklime and water. The limewash will protect the mud mortar on the face of the wall.
- E) Break and remove the concrete surface, resurfacing this as necessary with a water permeable material such as gravel. Earlier cobbles from the ginnel may remain. If not, the ground should be dug down and crusher-run aggregate, 20mm to dust introduced to facilitate future drainage. If drainage or sewage pipes allow, the level of the ground should be taken down to be more like that within the building.

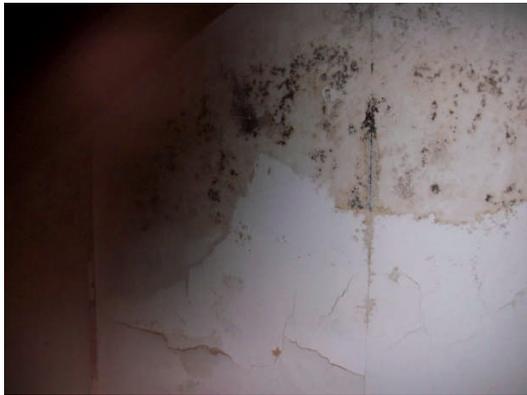
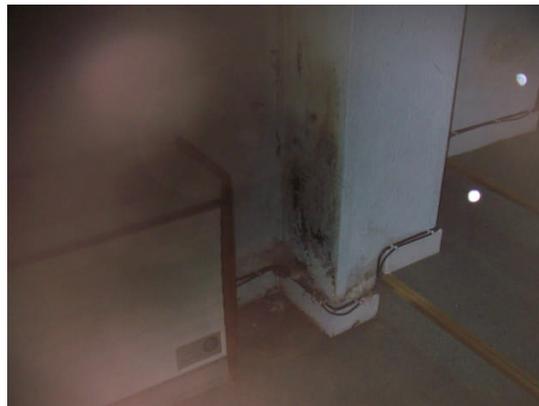
In this case, the internal walls have already been tanked, effectively. They have been rendered with a hard cementitious mortar. Whilst this will be causing problems within the wall, it is at least the case that breathability is possible to the outside wythe of the wall, since this remains eminently vapour permeable.

The problem that is presenting today, with degradation of paint and painted wallpaper is, in fact, caused by the cement mortar and its impermeability. The building having been empty around 12 months, condensation on cold walls has led to the decay of surface treatment upon these walls, especially where these walls are already wet behind the minimally permeable render-coat. This effect will have been much less pronounced when the building was in use and heated.

There would seem little virtue, therefore, in doing other than removing wall-paper and stripping the wall surfaces back to the cement render-coat at this stage. Longer-term, and perhaps as part of the programme of refurbishment works to this building that will be inevitably required prior to its being let once more, consideration should be given to the wholesale removal of this wall-covering and to its replacement with lime mortar. This will regain the correct performance for this building.
