ST. MARY'S CHURCH OLD MALTON

(FORMERLY MALTON PRIORY)

WEST DOORWAY

CONDITION

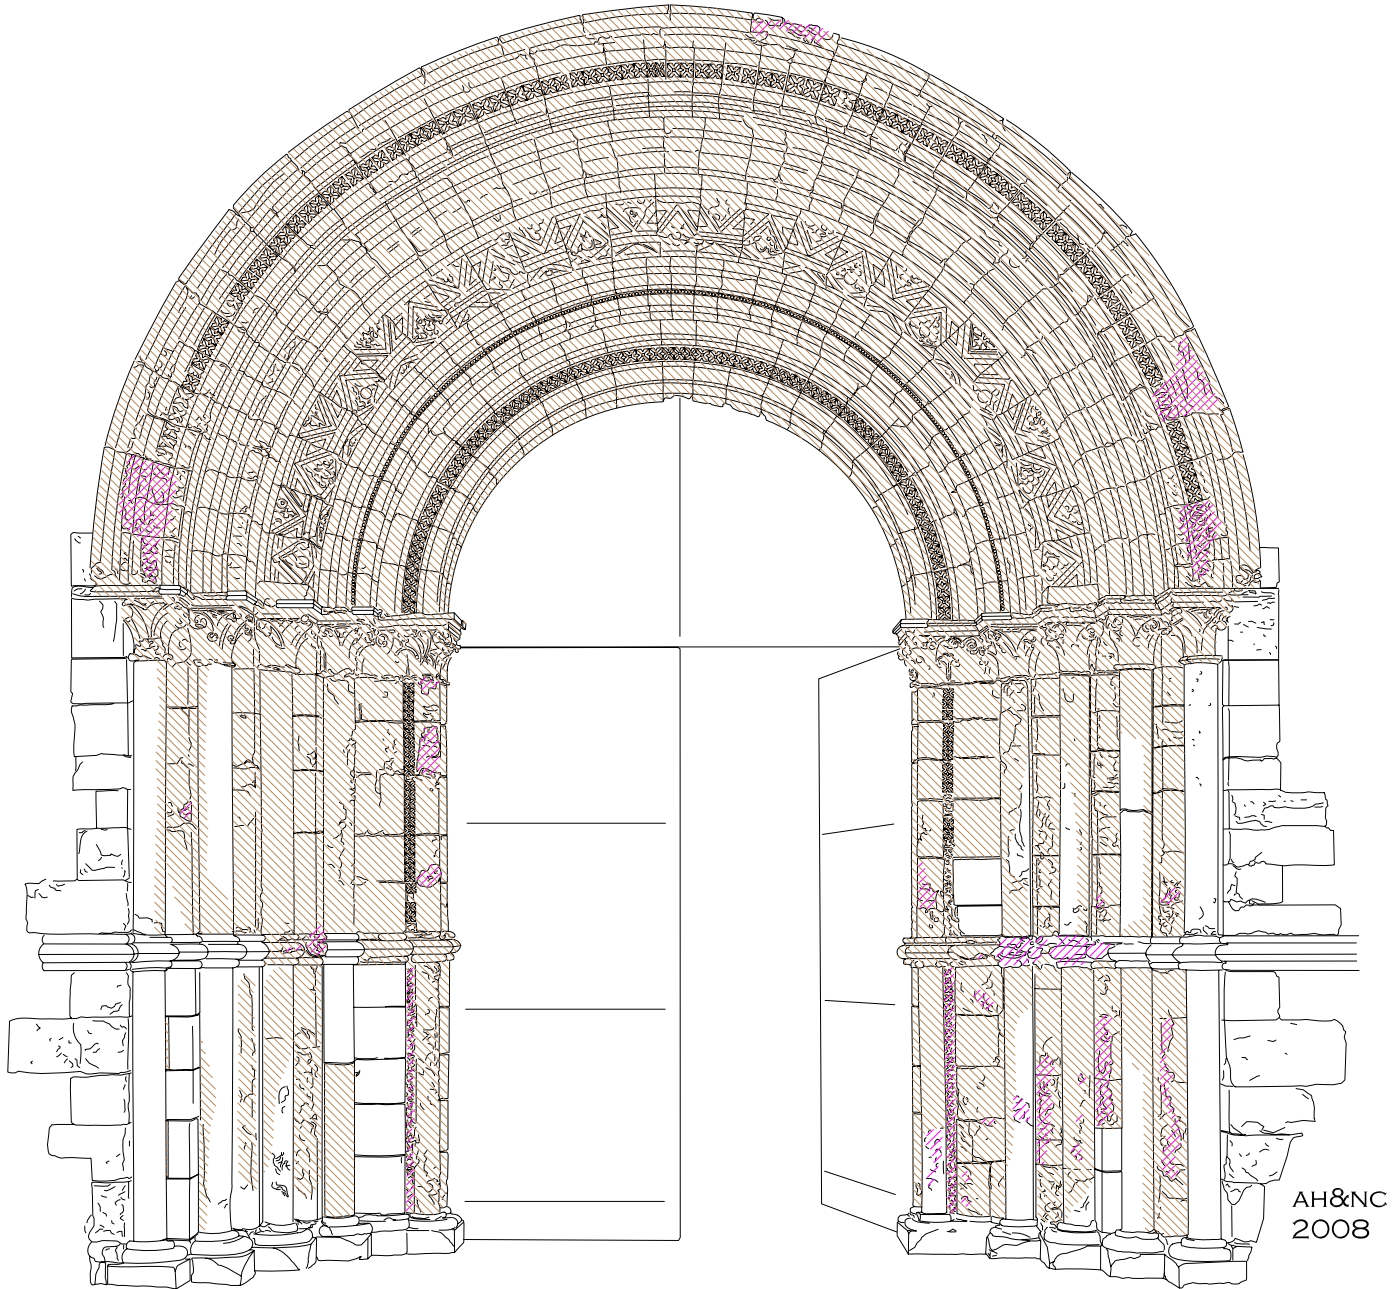
PRINCIPAL ZONES OF
SALT-RELATED DECAY
CAUSING BLISTERING
AND DE-LAMINATION

EXTANT SILICATE
COATING APPLIED
1960
