THE ROCKINGHAM MAUSOLEUM
WENTWORTH, SOUTH YORKSHIRE

To clean or not to clean?

nigel copsey
January 2007

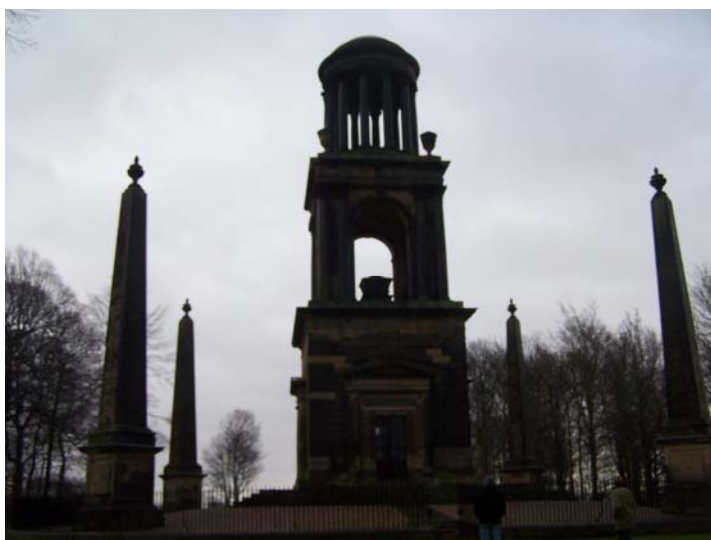
The Rockingham Mausoleum. Note the as yet little-soiled replacement stonework, as well as the cleaner sections beneath cornices, illustrating the limit of effectiveness of drips. Also the grey chemical cleaning test panels to the lower right-hand corner

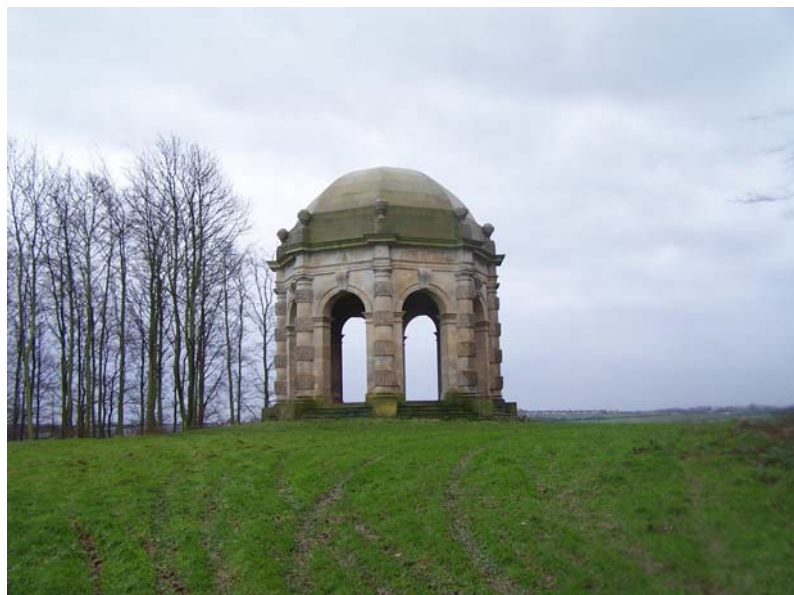
The Doric Temple

The blackening of the Doric Temple was likely a combination of soot and algae across most of the building. The pattern of decay in the sheltered underside of the dome, and particularly to the inner cornice, is the most dramatic upon the monument. Given the high exposure of the temple to the elements, this was the part of the building most protected from the falling and driven rain, and the only part that remained dry most the time. This pattern of the decay suggests progressive blistering and spalling of the stone in these areas. Such decay in such a location might be expected upon a limestone or a calcareous sandstone building, due to calcium sulphate crusting. This seems unlikely to be a factor here. In the absence of a calcium carbonate content in the stone, it may be that this area represented a drying zone for salt-laden water soaking through from behind the parapet at the base of the dome of the temple. The source of these salts may have been sulphate and nitrate rich aerosols from industrial emissions nearby.

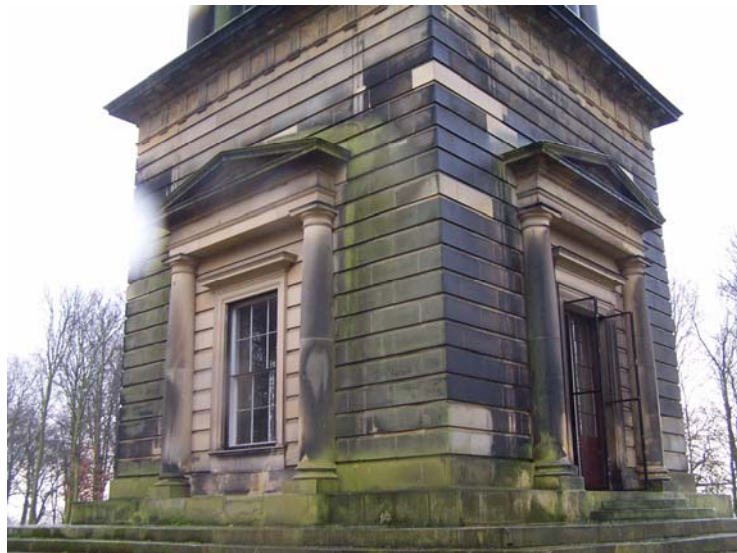
Note that the elevation that faces the prevailing wind is blackened, whilst the leeward elevation is green. This may be due to a higher concentration of carbon aerosols from industrial pollution on the face that receives the most direct, windblown precipitation. Note also that the algae has reasserted itself more readily on the leeward side than upon the more exposed –and blackened–elevation.

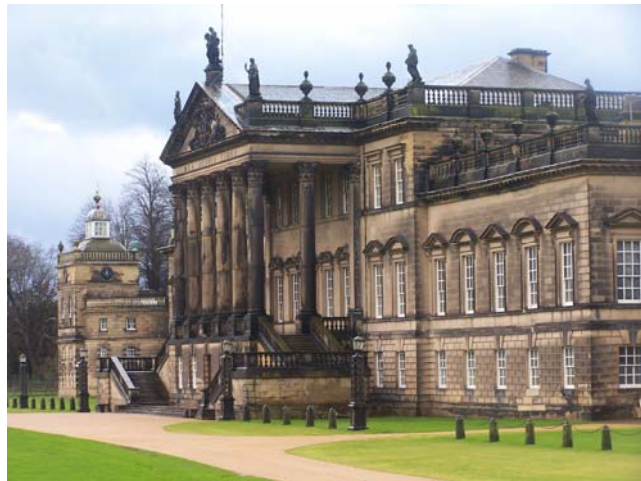
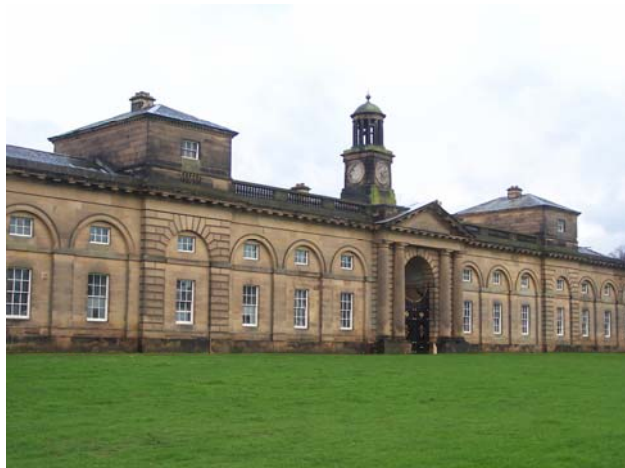
The much less exposed and much less frequently wetted and much less extensively soiled front elevation of Wentworth Woodhouse,

Similarly, the stables of Wentworth Woodhouse. It is not known to me if, when or how these buildings might have been cleaned. Note the heavy soiling of weathering and frequently wetted elements

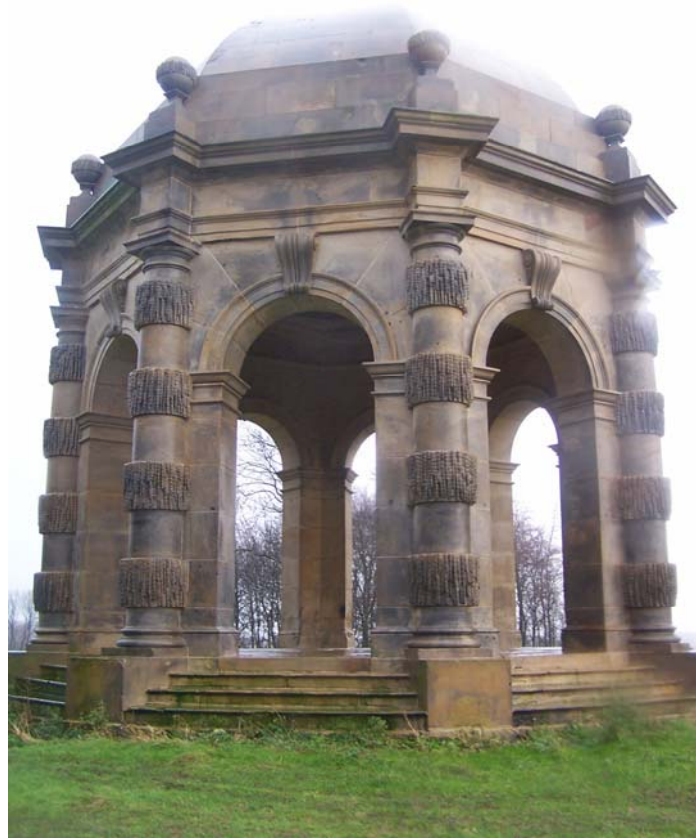
The Doric temple is, indeed, much cleaner than the mausoleum. Clearly, and predictably, however, the algae and, it would seem, the soot is beginning to re-establish. It is also evident that the rinsing out of the chemical residues, presumably with water at high pressure, has left its own particular imprint upon some of the stonework, at least, in the form of wavy lines and stripes. Some soiling that was driven into the porous sandstone appears to be working itself back to the surface in less than attractive ways.

The Doric Temple. Re-establishment of soiling is well underway after 12 months, or else this is a re-emergence of soiling driven deeper into the stone during the cleaning process.

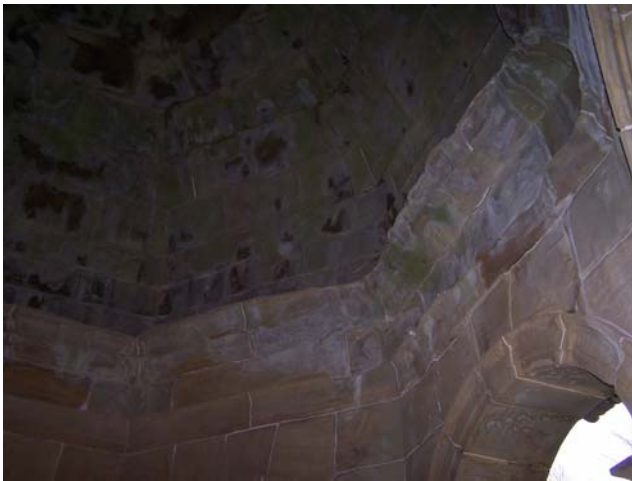
Inner cornice and underside of the dome. Note the extensive algal bloom, as well as significant salt efflorescence. Clearly, water continues to penetrate the dome, carrying salts in solution and allowing algae to thrive. The source of the salts may be pollution; it may very likely be chemical residue (see Andrew, plate 5.3 p78)

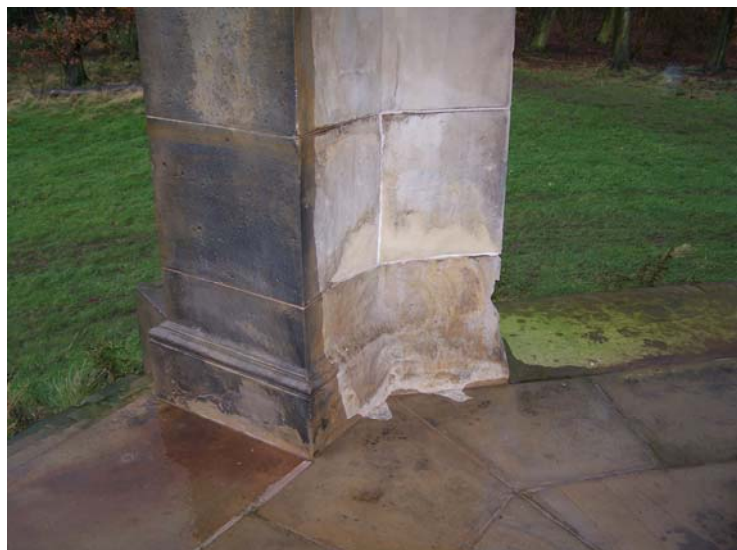
Decay elsewhere is most likely attributable to the activity of ground-salts at lower levels. Ground salts rising into the masonry in solution during wetter conditions have crystallised just behind the face of these stones (breaking down the matrix of the sandstone, the suddenly unbound grains of silica falling away. The matrix so weakened by such cryptoflorescence leaves the stone eminently vulnerable to wind-scouring).

*Doric Temple:
Decay caused by
groundsalts in rising
damp. Note the significant
resoiling of windward
stonework.*

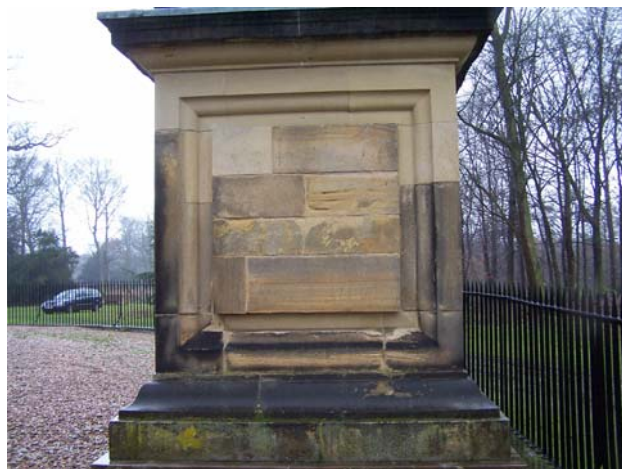
Obelisk plinth

The chosen stone does not appear to be the best of matches for the original, lacking any apparent colour variation. It is not known quite how extensive was the erosion of those stones that have been replaced, whether their decay was structural, or whether lime mortar repair might have been appropriate as an alternative to complete replacement. The new stone has yet to blend in or to attract any significant soot or algae, certainly to that on the more directly exposed elevations of the monument. It would likely continue to stand out as new and 'different' even after cleaning. Millstone grits of similar character and appearance to the original stone of the mausoleum is available relatively locally.

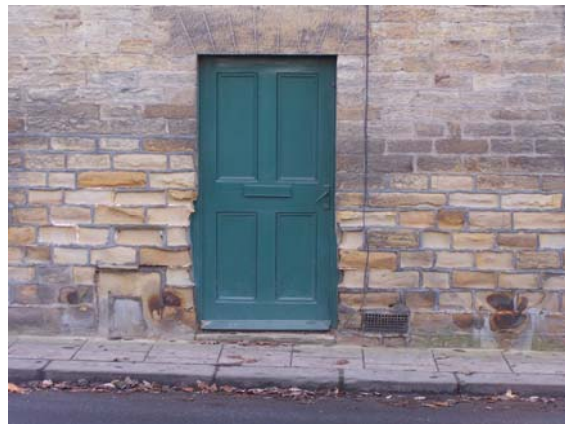
Significant erosion of local sandstone to the lower levels of a house in Wentworth village, illustrating the damaging alliance of salts carried in rising damp, salts splashed from the road and ordinary portland cement repointing.

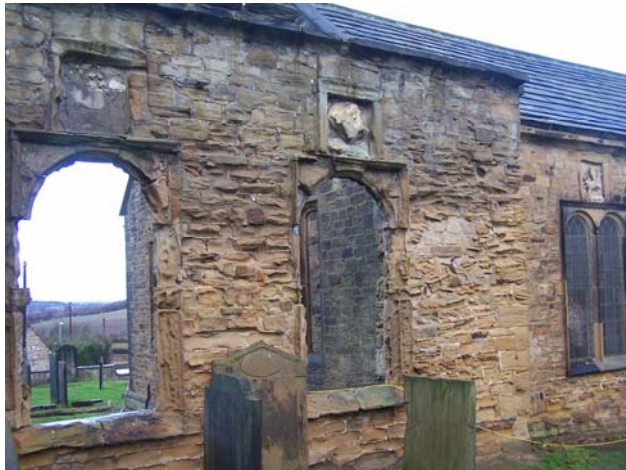
*Roofless wall, Holy Trinity Church
Wentworth village*

Decay to the walls of the church is particularly severe to the walls of the ruined and roofless section, as well as to projecting details and carvings, demonstrating the enhanced vulnerability of regularly wetted sandstone to erosion by wind, as well as to probable salt activity, and to freeze/thaw cycling.

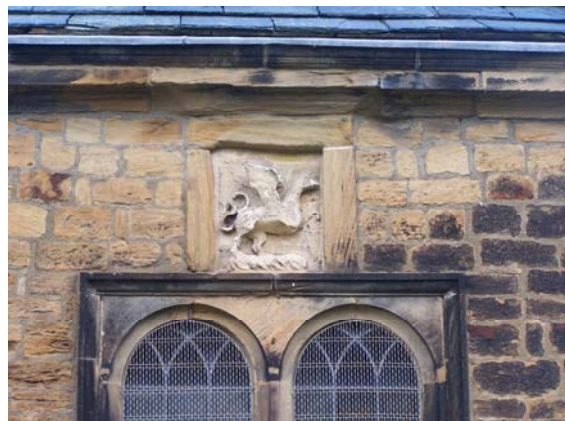
A part of the church defended by roof and good detailing. Same aspect as the heavily eroded wall above.

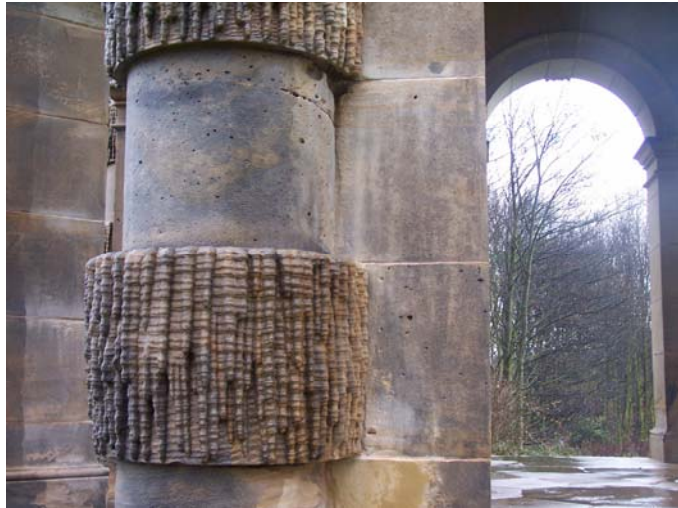
Pitting of stone to the Doric Temple. Was this present before chemical cleaning, or has it been caused by it? If the latter, is calcite present in the sandstone used? This pattern of pitting is typical of calcite loss due to acid cleaning (see Andrew, plate 5.1 p 75)
